Regarding 3 Hallmark Apartments, we believe that the property has been left in a much better state than how it was originally leased to us, and we think it's unreasonable to have any of our deposit monies deducted.

Entrance Hall

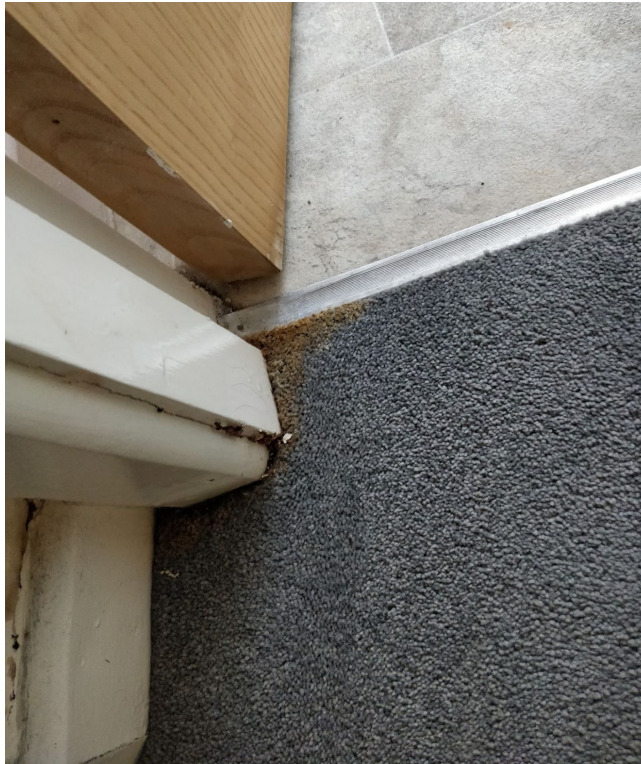
General comment on the above photo - note the dust and filth on the skirting board - this is considerably worse than the clean and tidy state we left the apartment in. Your check out report noted no dust at all throughout this entrance hall section.

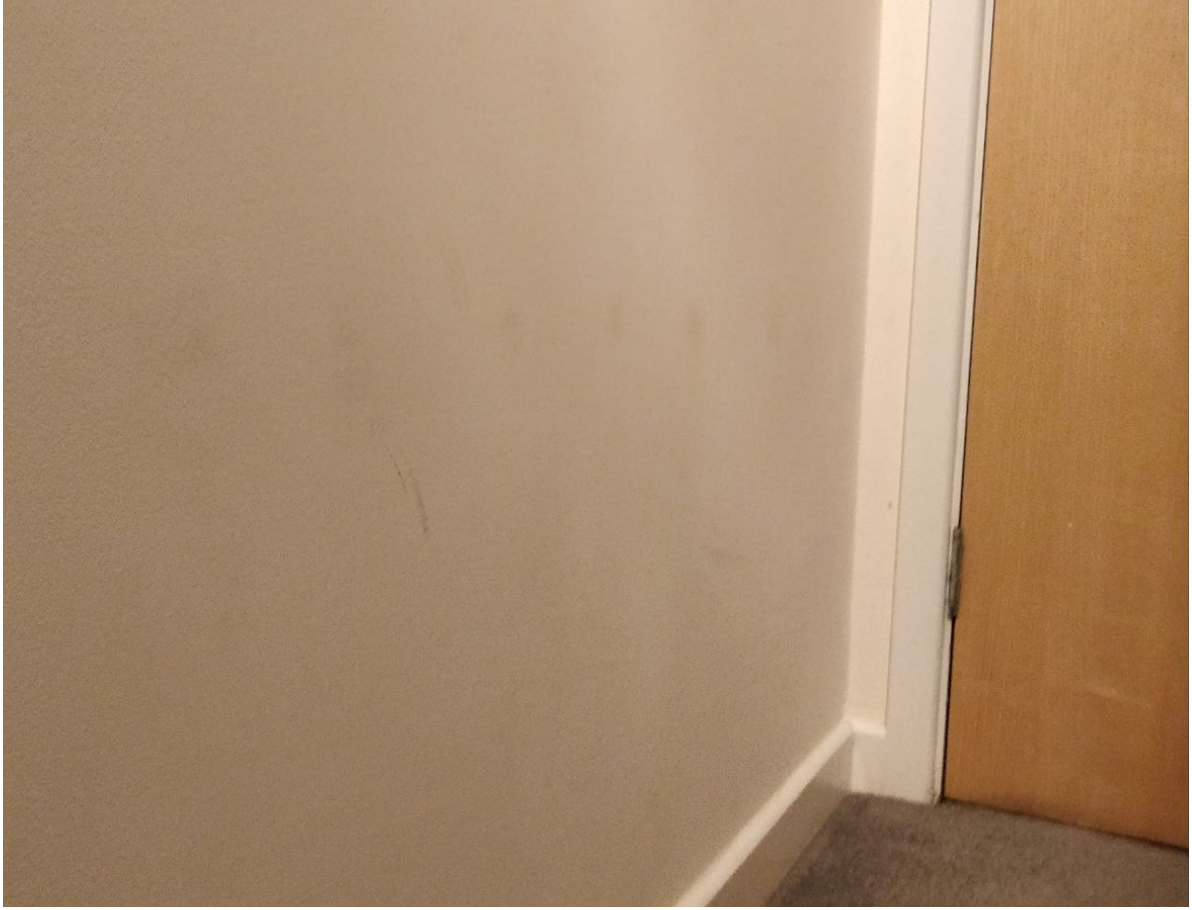
Referring to the scuffs below door level, this was taken when we moved in; a large black scuff on the wall behind the entrance door. There are also several small scuff marks/greasy marks along the wall, and skirting boards.

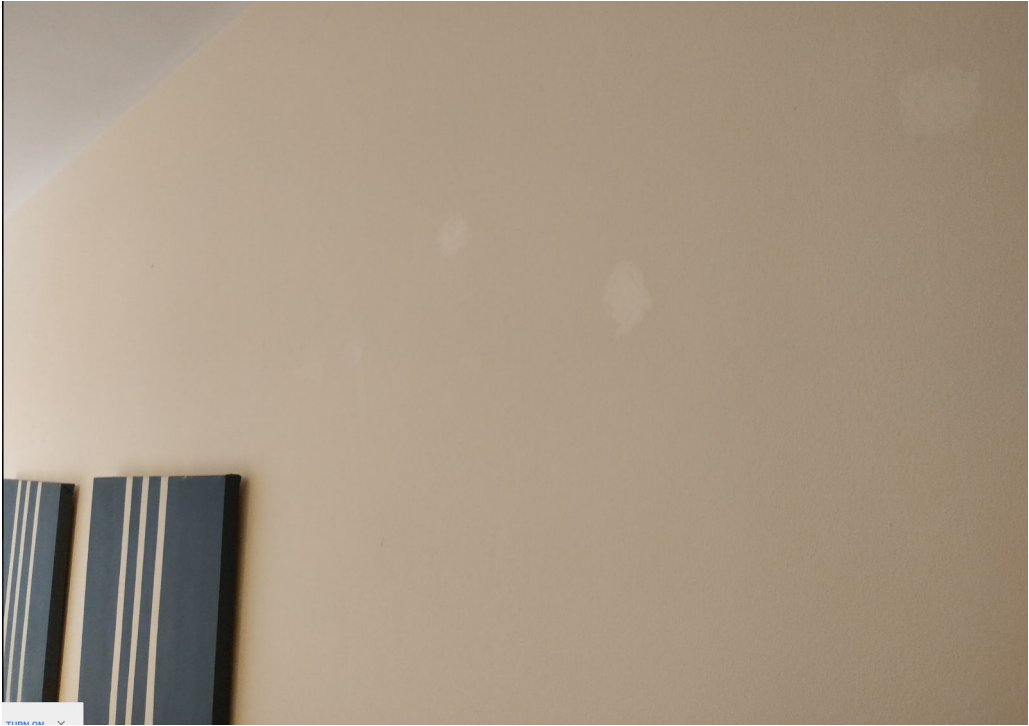
| | | | | | |
|---|---|--|---|---|--|
| | | we left. | | | |
| Walls | Paint patch work and 1 nail | <table border="1"> <tr> <td>16</td> <td>Walls painted cream emulsion</td> <td> <p>Generally IGC, unable to inspect fully due to tenants possessions</p> <p>LHS wall: minor marks RHS of bedhead</p> <p>Facing wall: faint mark LHS of window</p> <p>RHS wall: marks around heater, blue tack marks around pictures to centre of wall, 5 filled in holes by door</p> </td> </tr> </table> <p>Nails were already in place upon move in - here is a photo of the paintings hung on the wall in the bedroom next to the filled in holes referenced in the move in inventory excerpt above.</p>

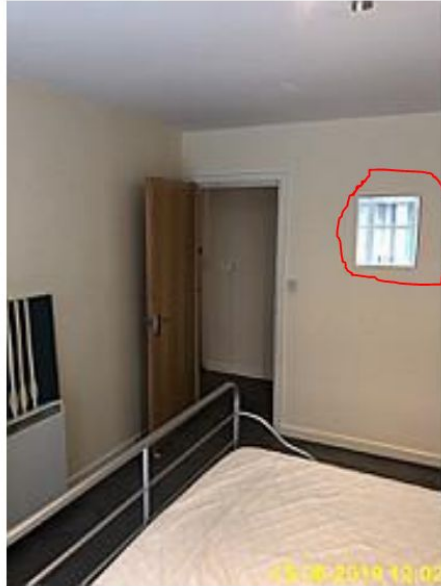
The two chests of drawers (bedside tables) that are noted in this bedroom, are the two missing bedside tables from bedroom two. Upon moving in there was no bedside table in bedroom one, this can be seen in the excerpt from the move in inventory above that lists bedroom furniture.

The new chest of 4 drawers was agreed to replace the 6 drawer unit which was completely broken (videos available upon request).

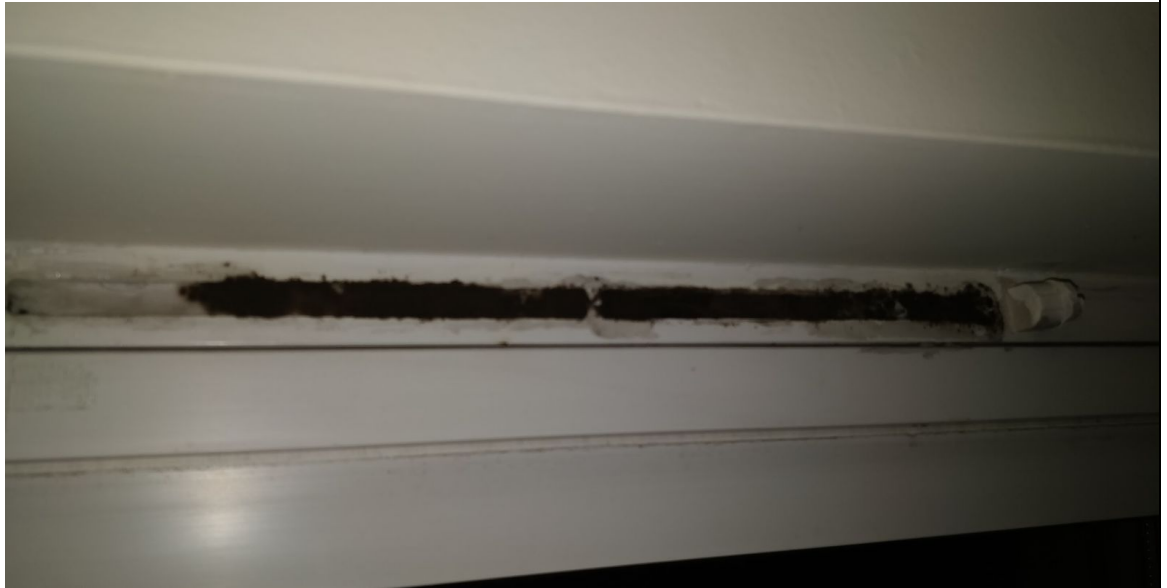
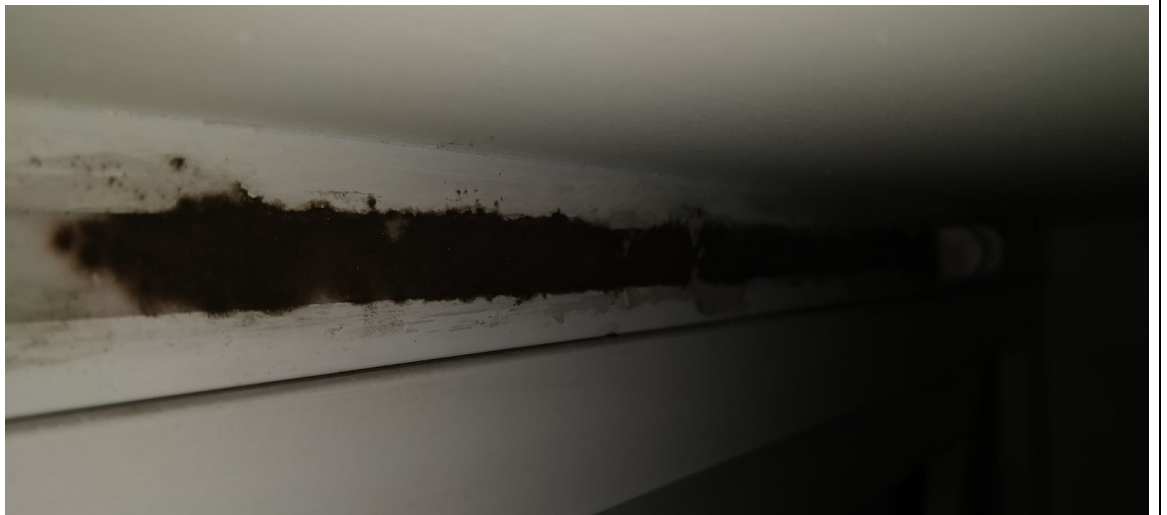
| Item | Check out condition | Our evidence | | | |
|---|--|--|---|--|---|
| Windows and frames | Dusty | The window ventilation upon move in was filled with white bathroom sealant which had been left to fester and grow mildew up to the point at which we moved in. This was the condition of the bedroom two windows upon move in - | | | |

| 47 | White framed double glazed window, 1 opening with white handles | Air vents missing and filled in to RHS, tape marks and scuffs around frame, mildew marks to LL sealant |

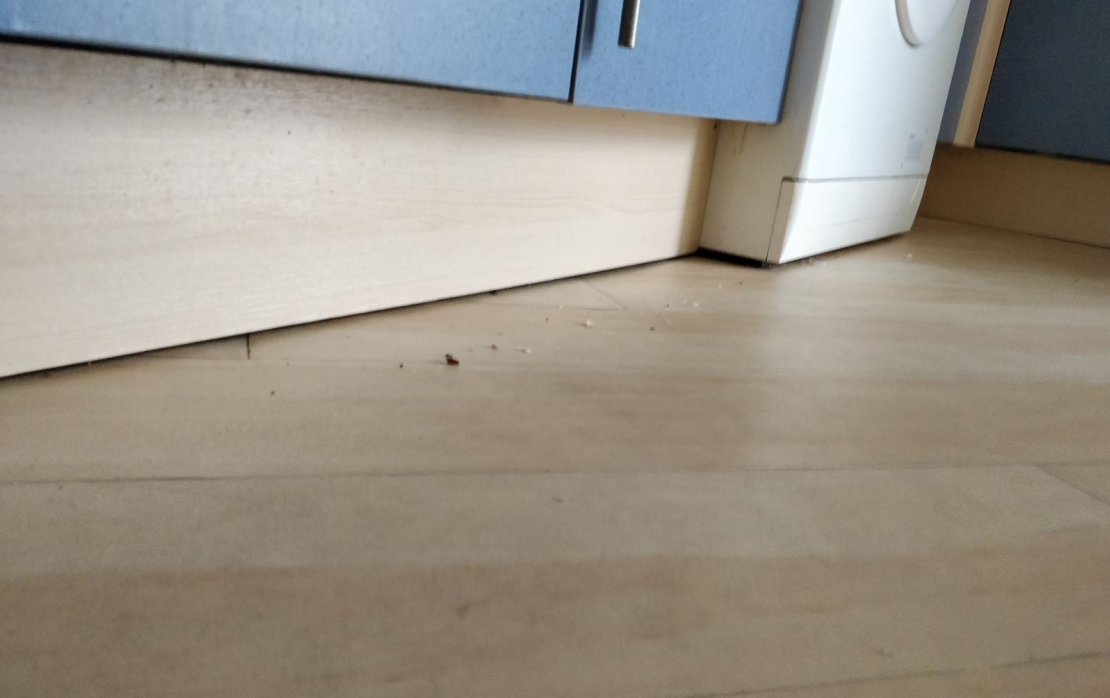
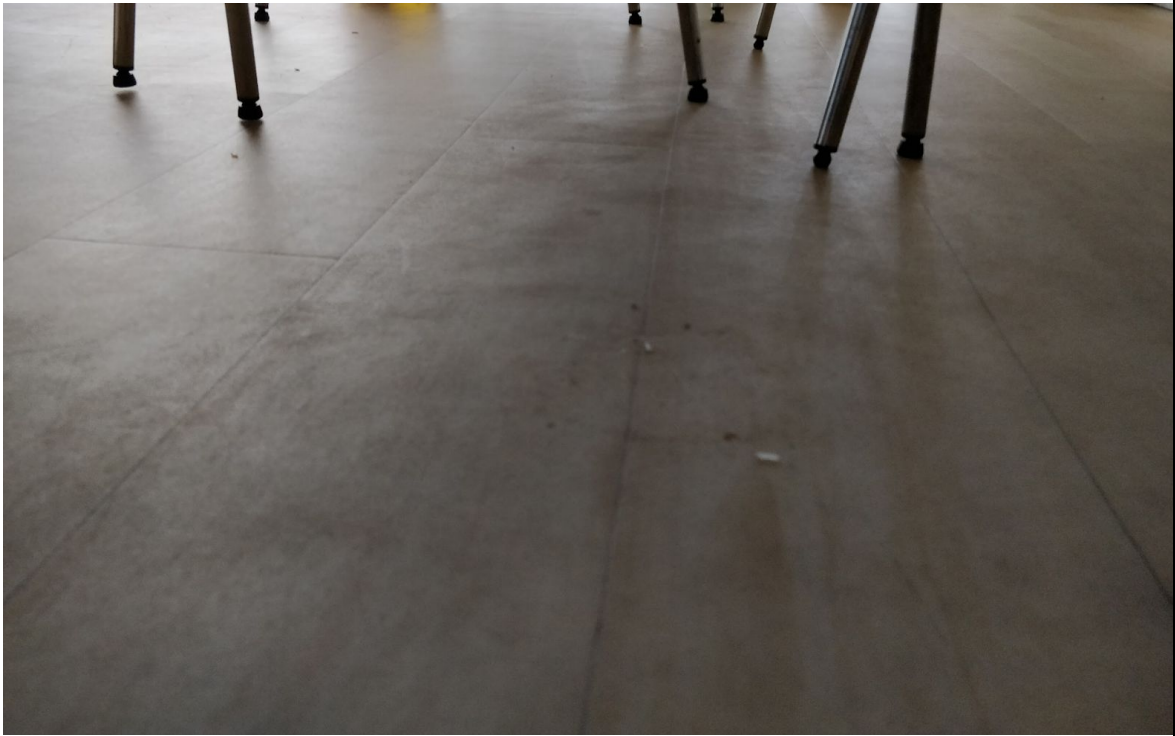
<p>The floor had not been cleaned at all and there was still food crumbs present from the previous occupiers. To complain about dust on the lights when we have dealt with this is</p> | 81 | Kitchen units: Blue laminate doors with chrome handles White and wood effect framed units | Wall units: black marks and scuffs to interior of back panels, clean, minor wear to exterior door RHS of cooker hood Base units: NUM around handles, light scuffs and marks to interior of units, no major damage seen |
| 81 | Kitchen units: Blue laminate doors with chrome handles White and wood effect framed units | Wall units: black marks and scuffs to interior of back panels, clean, minor wear to exterior door RHS of cooker hood Base units: NUM around handles, light scuffs and marks to interior of units, no major damage seen | | | |

| | | <p>reprehensible.</p> |

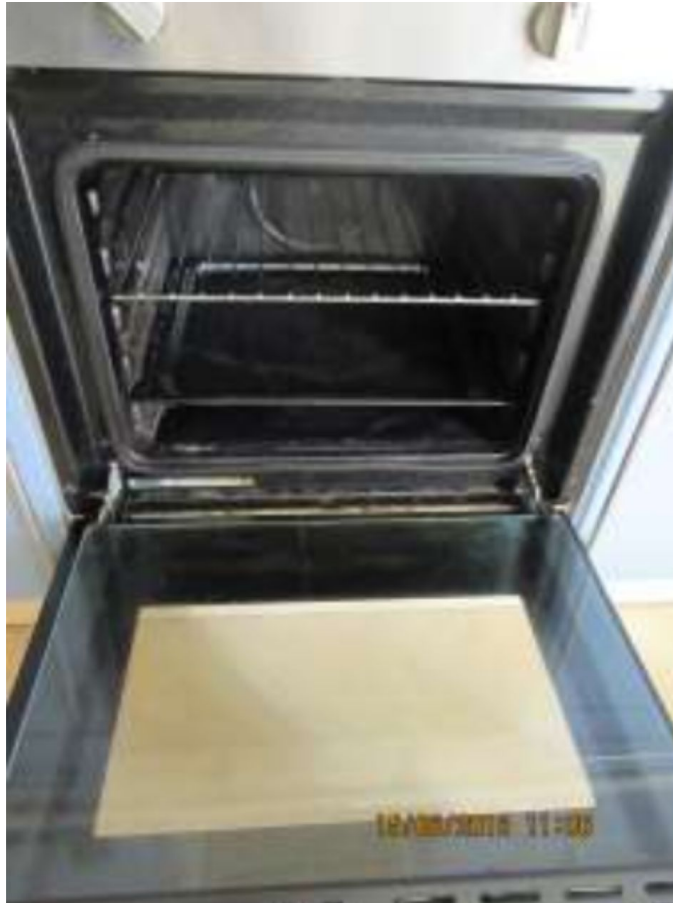
| Oven | Fully scaled and dirty | The following photo is the oven one week after we moved in from the check in inventory: |

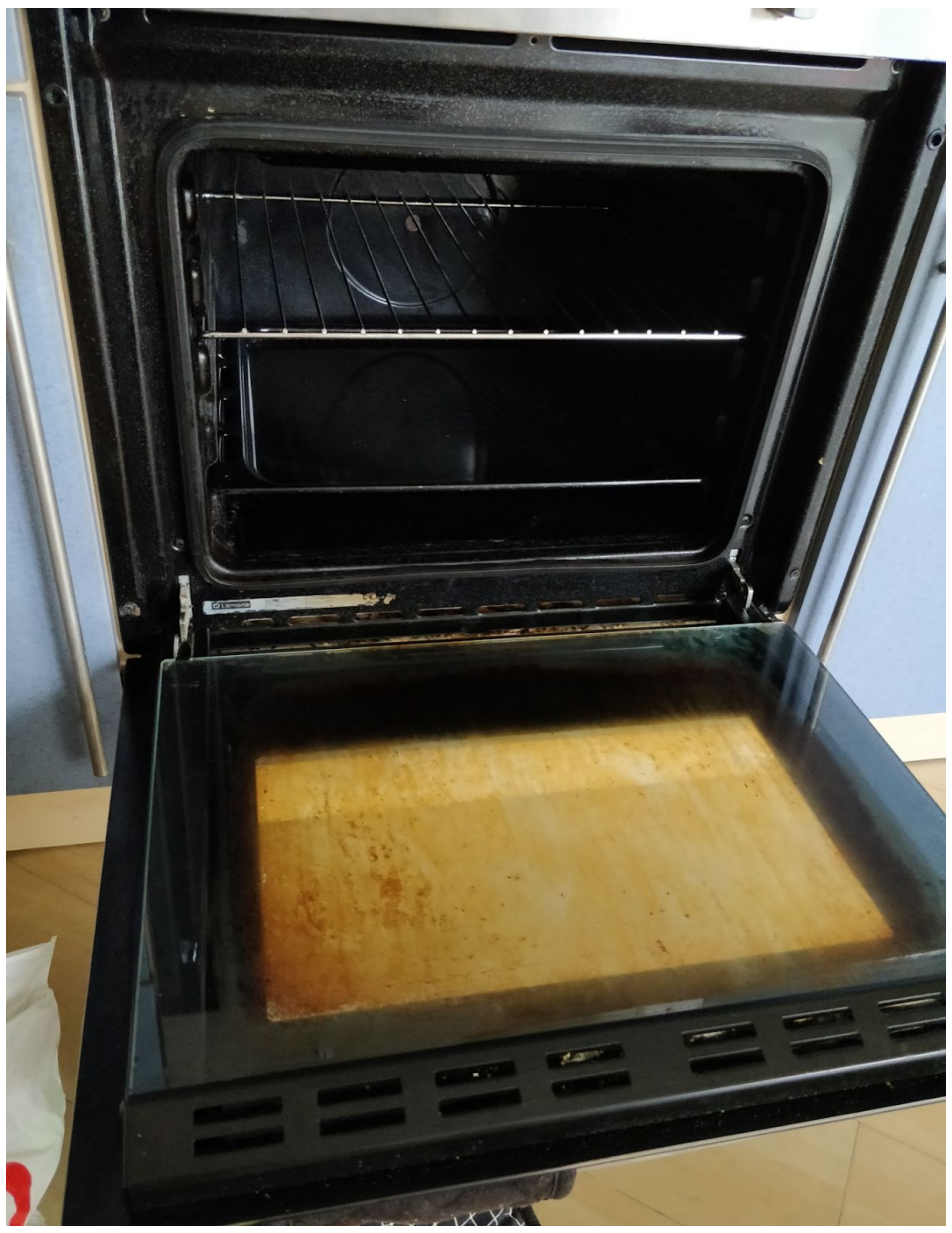
This is the standard to which we clean an oven. The following photo is the oven on the day we moved in one week prior.

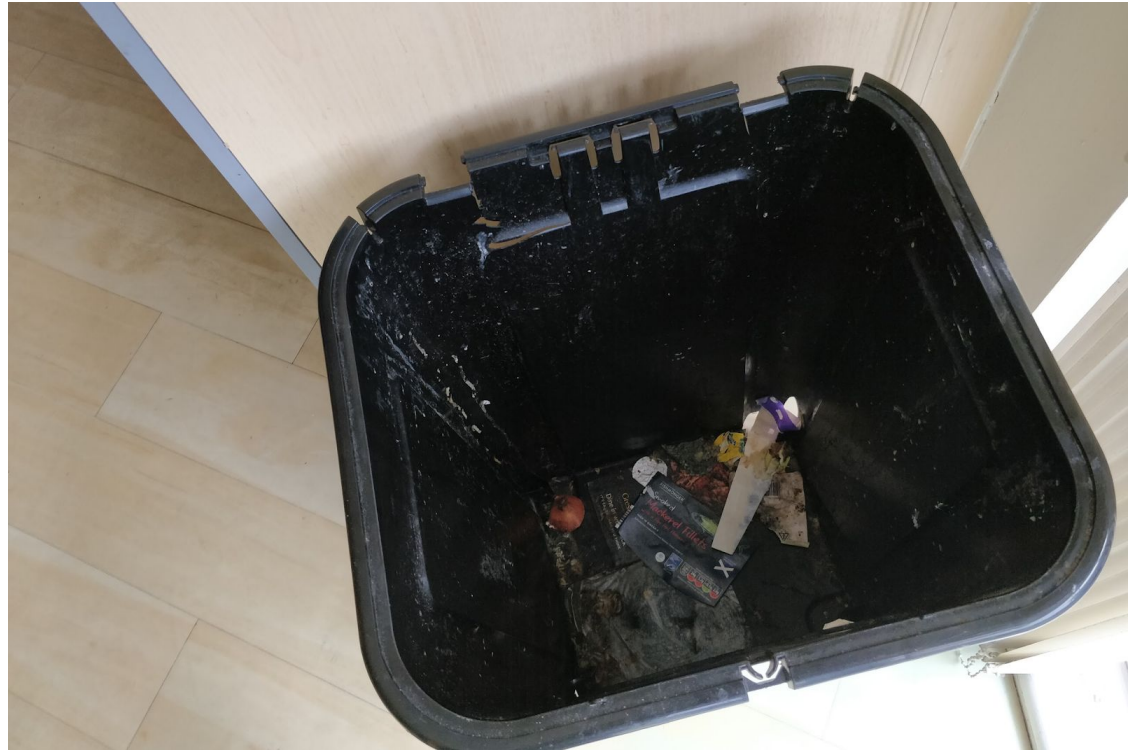
The disposal of the waste bin was agreed upon (by Charlie Rogers and the Landlord) No agreement to replace this was made so we used our own waste bin which we took with us when we left. Here is the waste bin as it was when we moved in along with the agreement to dispose of it.

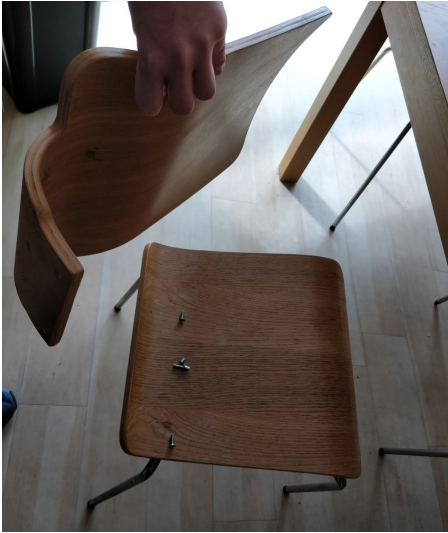
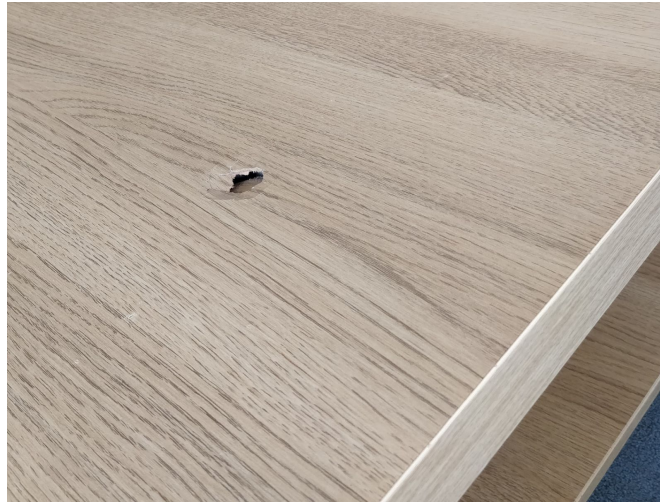
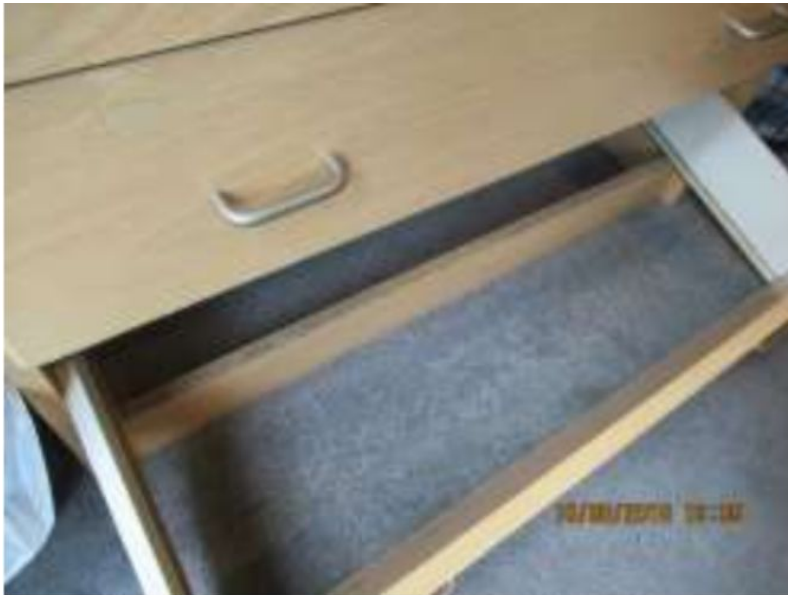
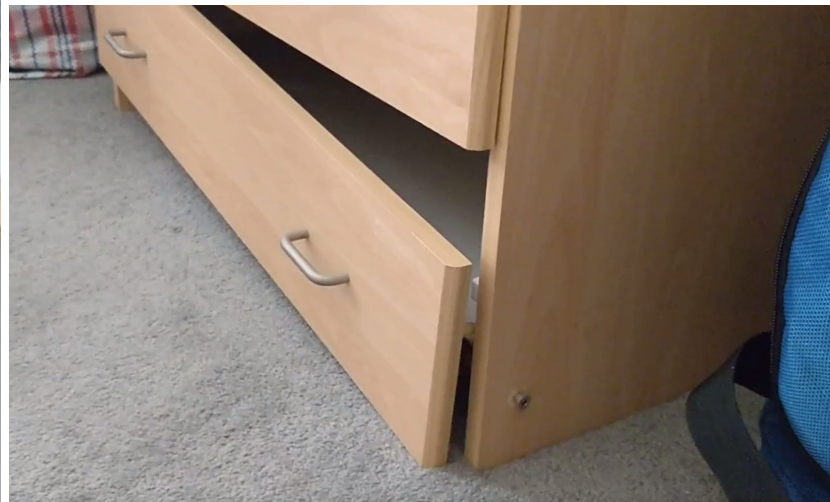
When we moved in, there was a light fixture dangling from the ceiling. When we moved in, 4 different chest of drawers were broken and smashed, and several dining room chairs were snapped completely in half, or held together with only 2 instead of 4 screws. The coffee table had a hole in it and the sofa had collapsed on one side. Several of these things we saw during our viewing 6 weeks prior

to move in. We were told they would be addressed. Some of these have still not been addressed more than a year later.

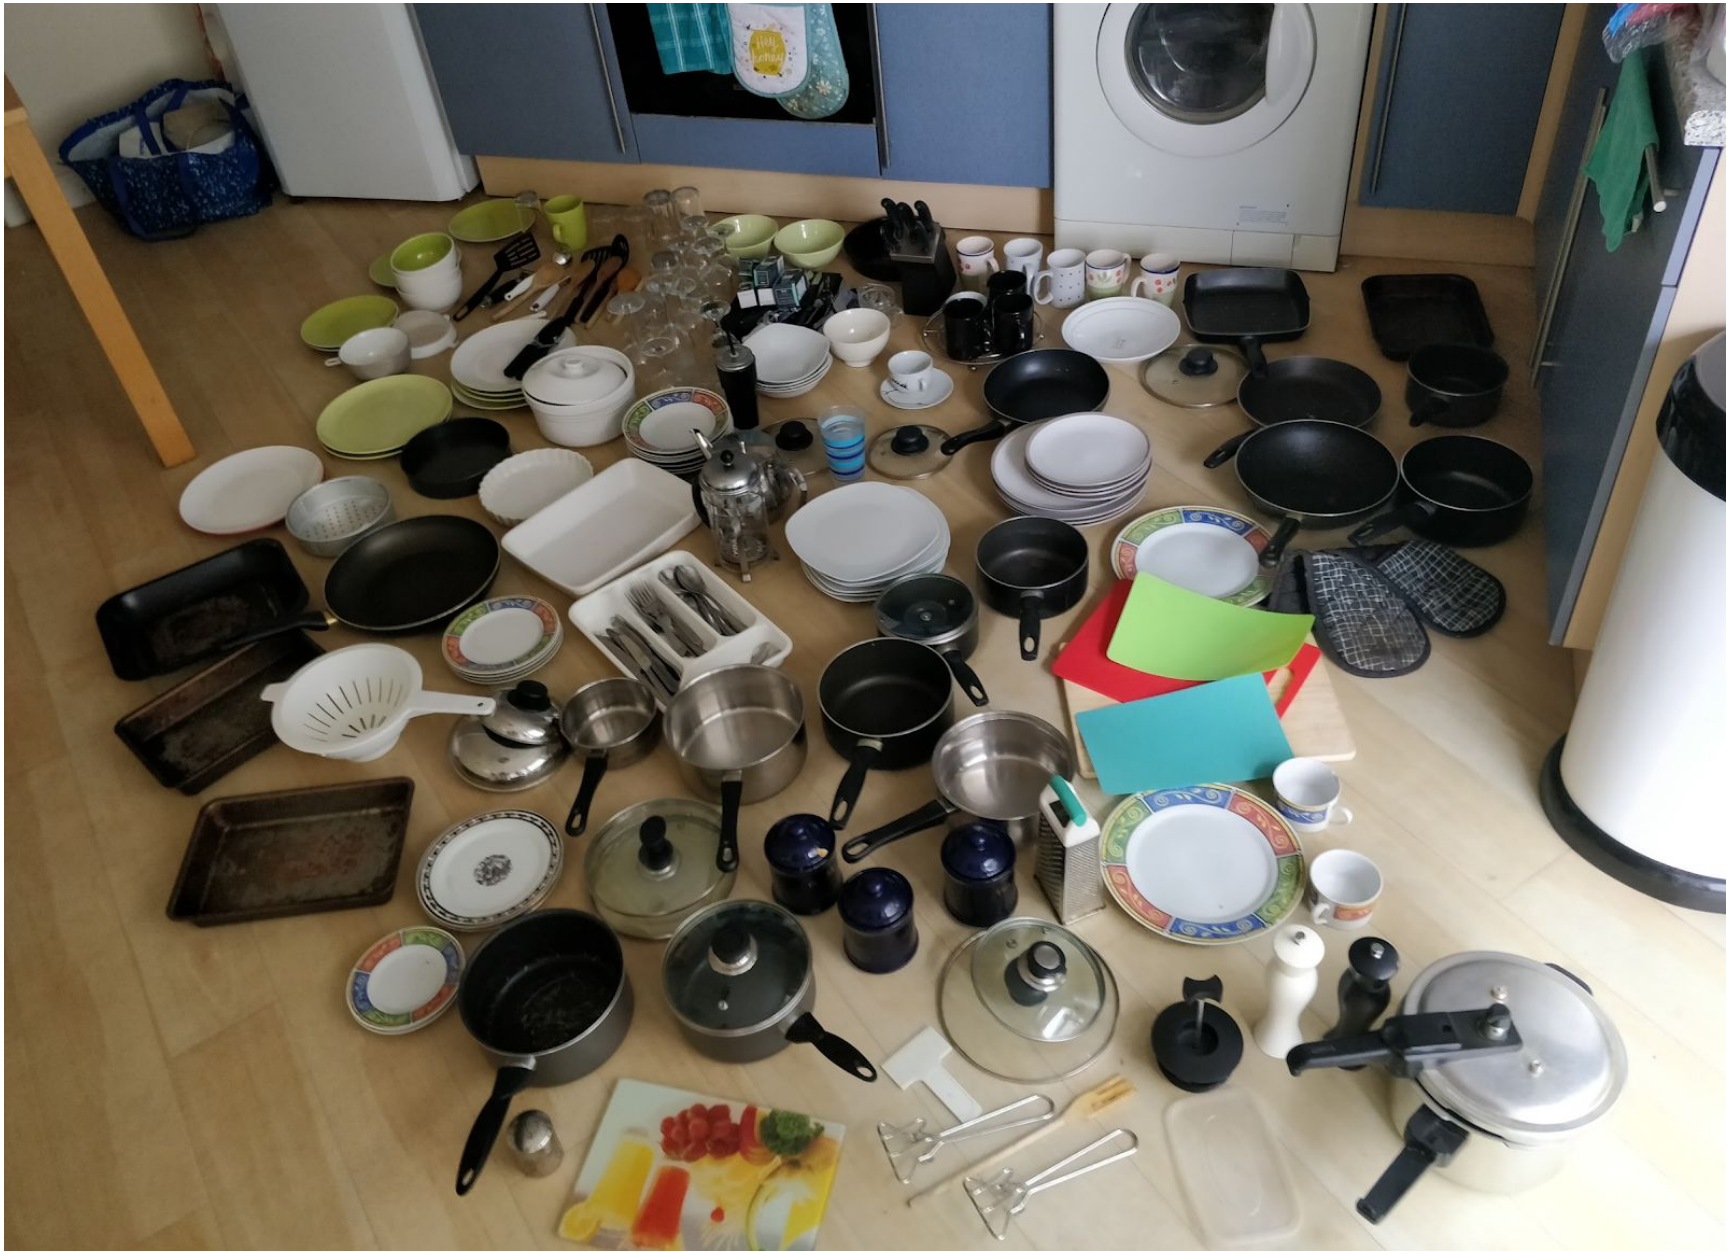
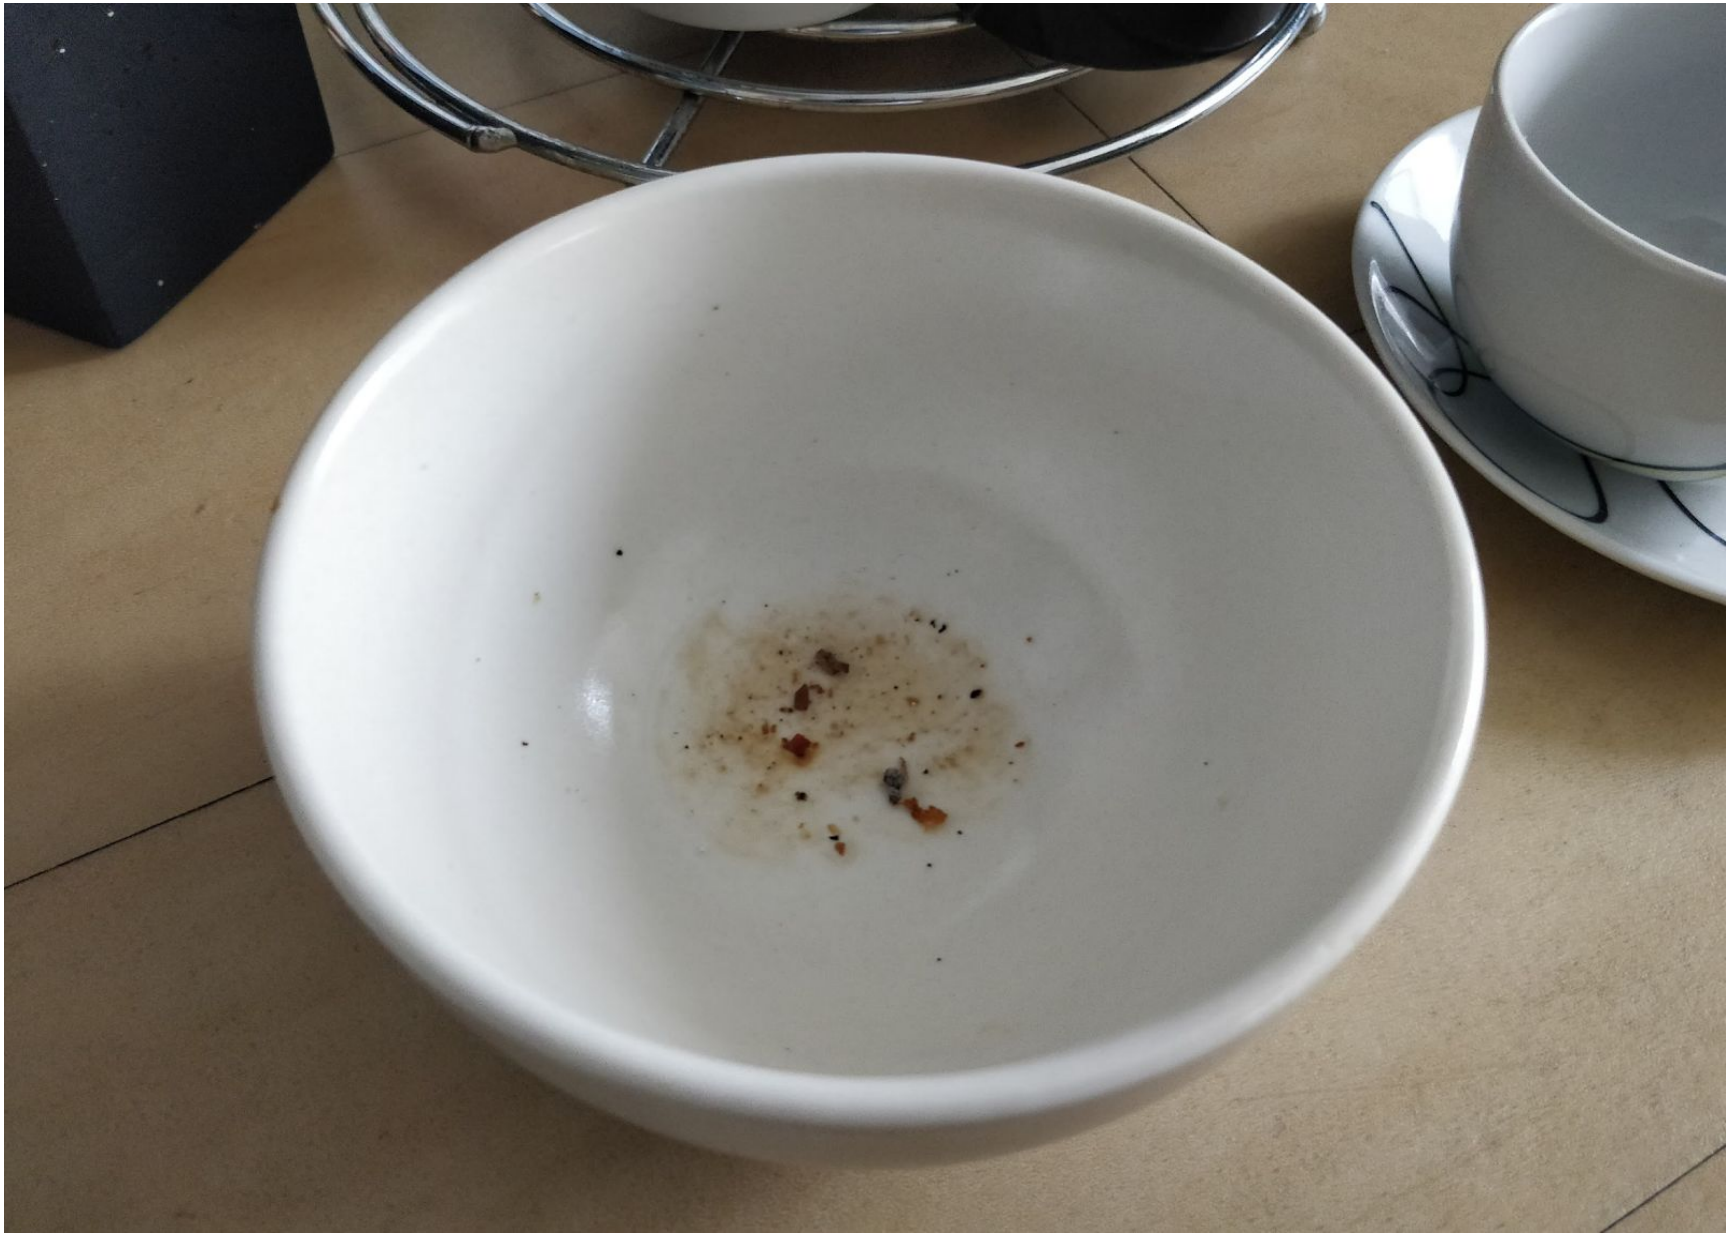
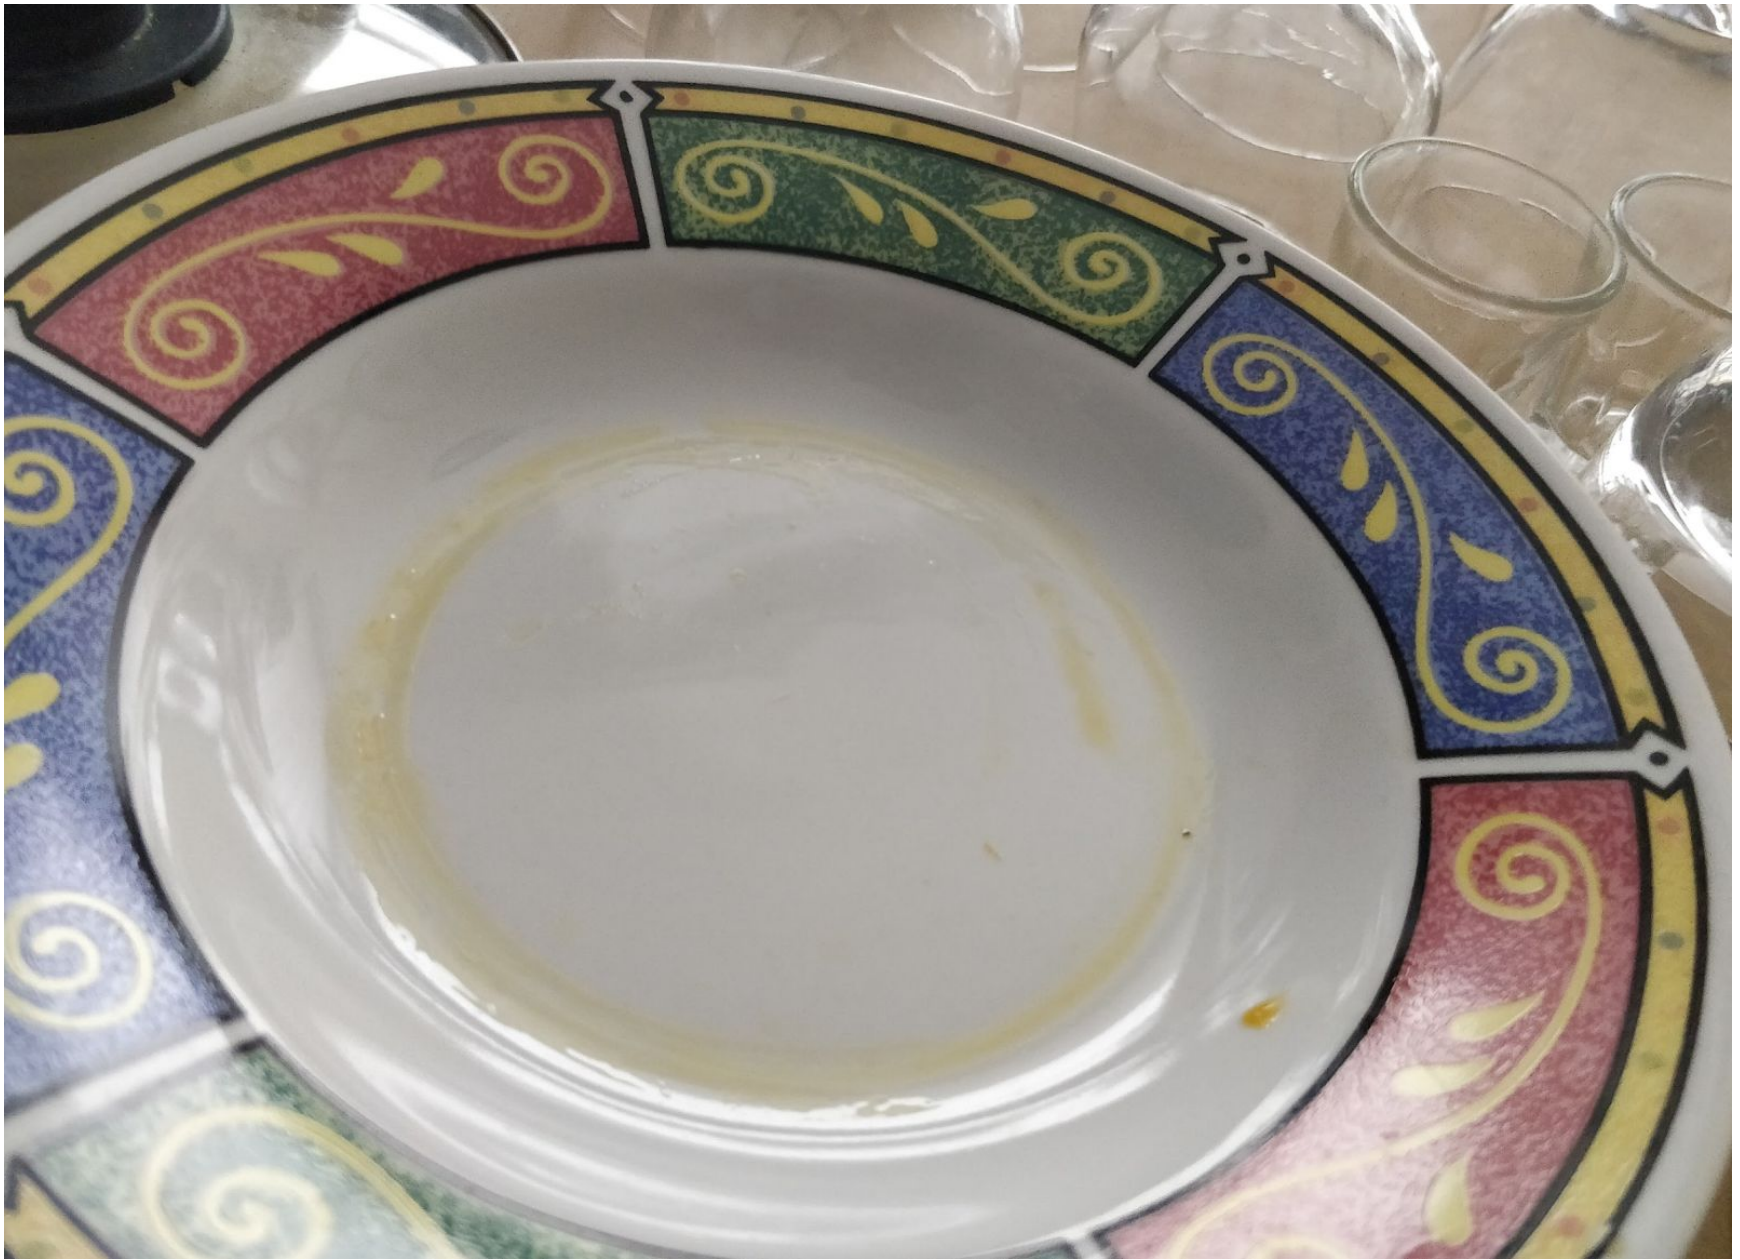
Seriously now, there are 236 assorted kitchen items under the kitchen sink. I conducted a full inventory of these when we moved in, as did the independent inventory company shortly thereafter, and we both found several of these items to be dirty (old food/new mold). To have this sat in a cupboard for over a year, after having been told we cannot dispose of it, is a joke, and a borderline biohazard.
